MONTEREY REGIONAL WASTE MANAGEMENT DISTRICT

DATE: May 14, 2021
TO: General Manager
FROM: Senior Engineer
SUBJECT: MRF and Landfill Access Road Asphalt Pavement Repair

MRF and Landfill Access Road Asphalt Pavement Repair

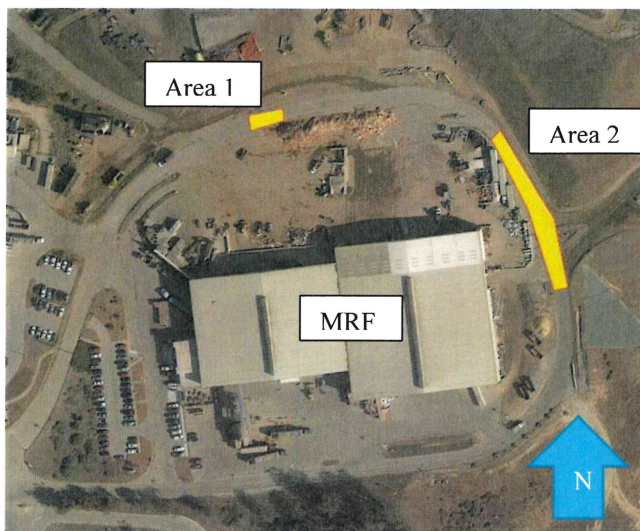
Area 2 in Figure 1 is one of the more critical locations at the site. This is the location where loaded vehicles turn east toward the landfill. Loaded vehicles that are headed to the MRF continue north. Conversely, this is also the location that empty vehicles leaving the landfill will turn right as they make their way to the site exit. The frequency of these heavy vehicle turning movements puts significant strain on the pavement. Considering the loads, the pavement has fared well as it has lasted beyond its expected service life.

In addition to the fatigue cracking, potholes have begun occurring and have made it difficult for vehicles to utilize the road.

This repair work is focused on the east side of the MRF where the significant pavement failures have taken place. The work includes removing the existing asphalt pavement in each area and recompacting and refurbishing the subbase materials. Once the subbase is recompacted a new layer of asphalt pavement will be installed to match the existing cross section depth of pavement.
