## MONTEREY REGIONAL WASTE MANAGEMENT DISTRICT

DATE: August 13, 2021  
TO: General Manager  
FROM: Senior Engineer  
SUBJECT: MRF Fire Sprinkler System Piping Protection

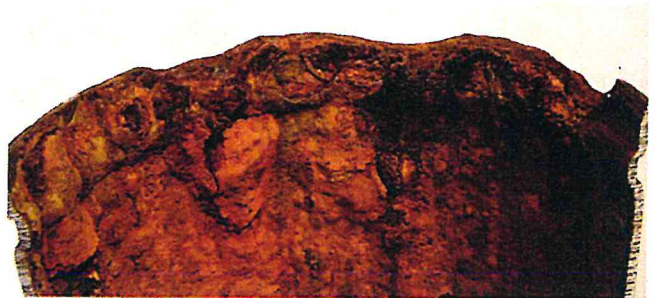
Oxygen corrosion is the primary and predominant source of metal loss in wet pipe fire sprinkler systems. The most common location for this corrosion, and resultant leaks, is at the high points of the wet pipe system where trapped air can accumulate. Pockets of trapped air act as reservoirs of corrosive oxygen, which will continue to dissolve into adjacent water and promote the corrosion reaction process until all the oxygen is consumed.

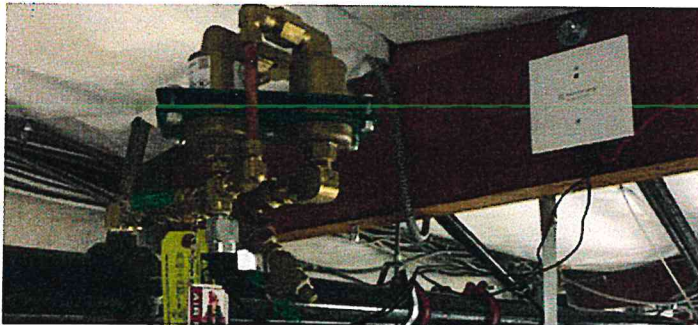
Oxygen Rich System

The best method for keeping oxygen out of sprinkler system piping is to vent the system by installing a Protector Nitrogen Inerting Vent (PAV-WN) on each fire system riser. This reduces the amount of oxygen available to react with the pipe wall by inerting the system with nitrogen to 98%. Below is a good picture of an oxygen rich system compared to an oxygen free system. Black water indicates corrosion and loss of pipe wall thickness, weakening the pipe and making it susceptible to leaks.

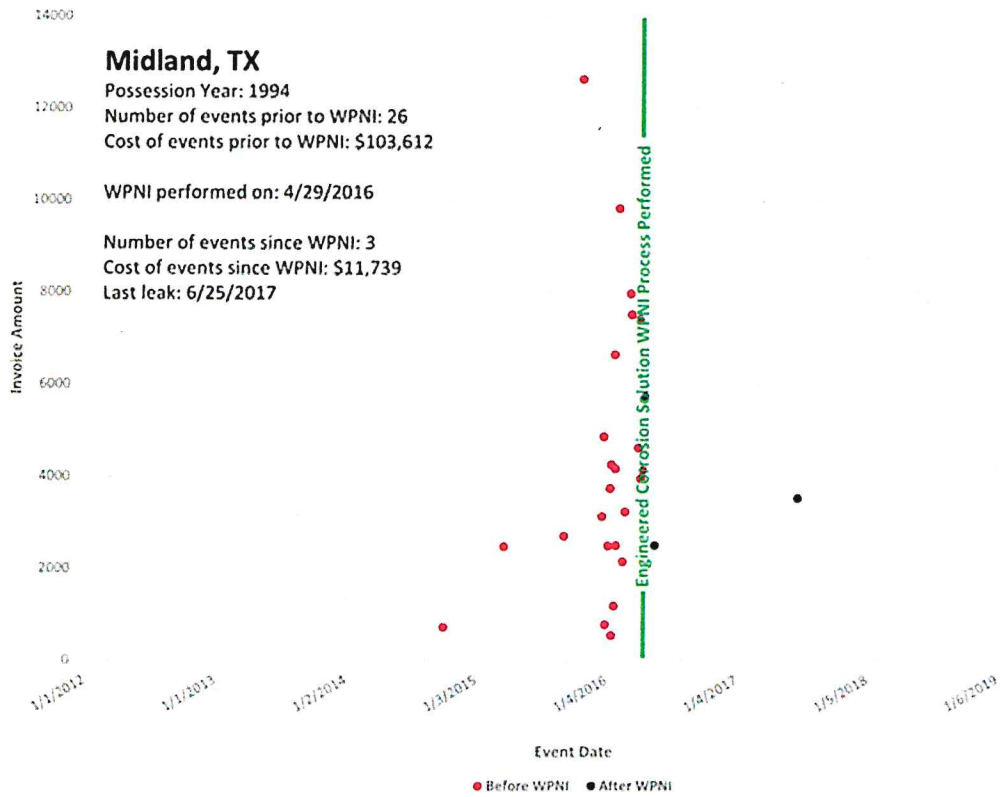
Inerting with nitrogen in similar fire sprinkler systems has shown positive results in prolonging the useful life of the piping. Big box warehouse facilities have been analyzed before and after nitrogen inertion to evaluate the effectiveness of this approach. The results of one case study, that is considered to be typical of most cases, is presented in the chart below. The red dot's indicate piping leaks before the nitrogen system was installed, the green line is the point when the nitrogen system started operating, and the black dot's represent the leak repairs that occurred later,. The pipe repairs all but stopped. This was a 20 plus year old system similar to the one at MRWMD MRF.

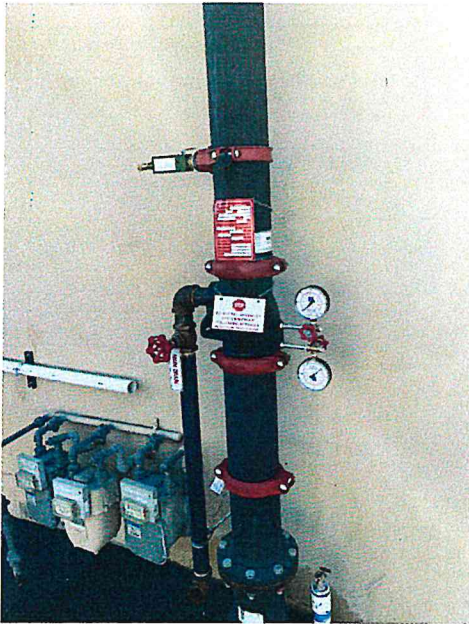
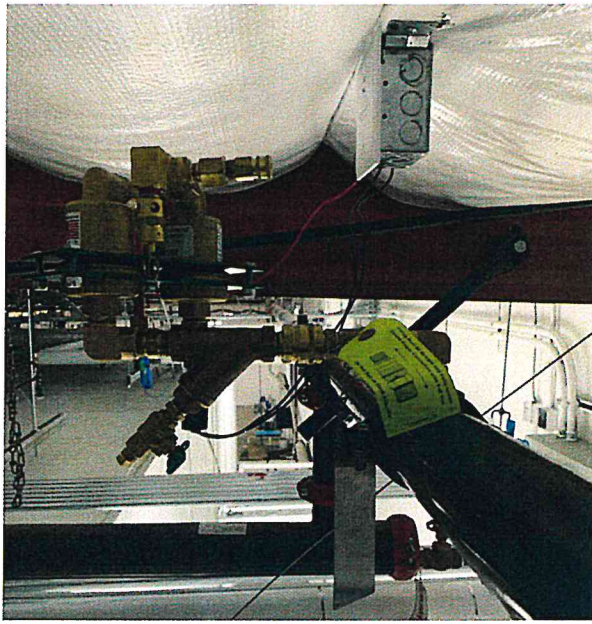
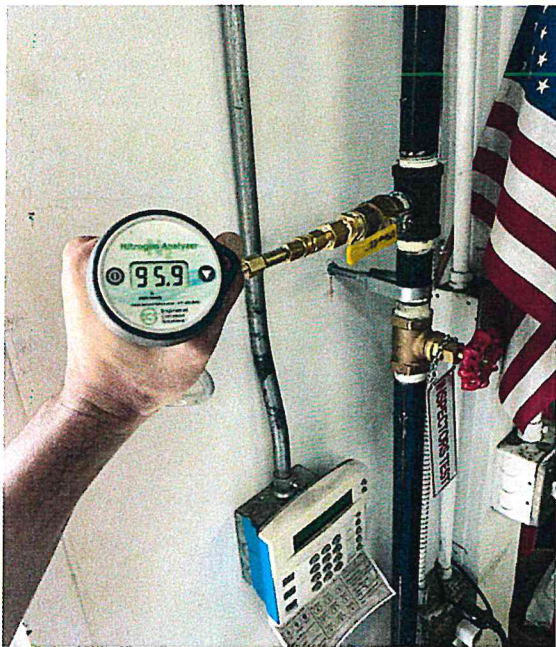
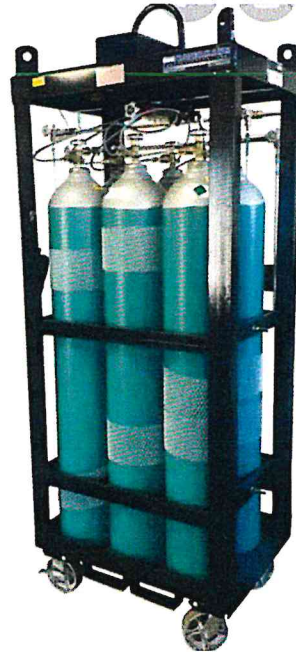
The proposed Wet Pipe Nitrogen Inerting system project will include installation of automatic air vents, nitrogen injection ports, inspector test locations to enable hand held gas analyzers to be used, and inerting gas.

Once the nitrogen purge system has all the components installed, the sprinkler system piping will be filled with water until all low points and vents have bled all the air off, then the nitrogen bottles are connected to the injection port and turned on to start the inerting process. The system goes through a series of 'burp' sequences to displace any remaining air until the hand held analyzer reads 98% nitrogen at the test stations. Then the sprinkler system is closed up, the nitrogen bottles are disconnected, and the sprinkler system is returned to normal service. Airgas (or similar nitrogen supply vendor) comes and picks up the nitrogen bottles. No nitrogen bottles are keep onsite after initial filling. The inerting sequence is repeated whenever there is a damaged sprinkler head or broken pipe that sets the sprinkler alarm system off (about \$1,300 per occurrence).
